# **The Road Inventory of Hanalei National Wildlife Refuge Kilauea, HI**

Prepared By:  
Federal Highway Administration  
Central Federal Lands Highway Division  
April 2013

# Hanalei National Wildlife Refuge - 12522

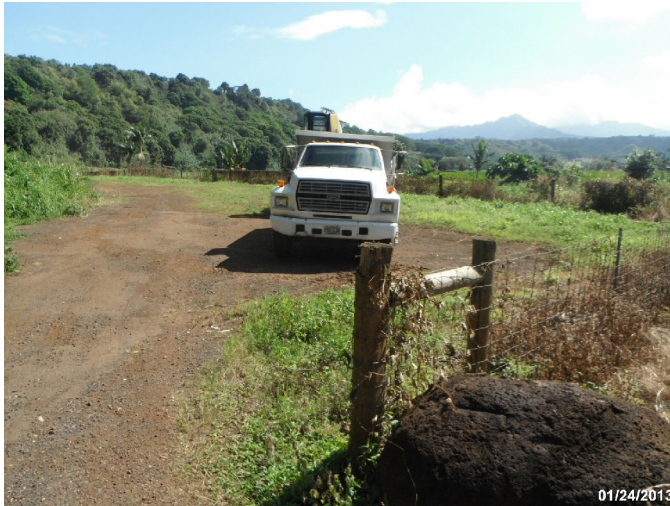
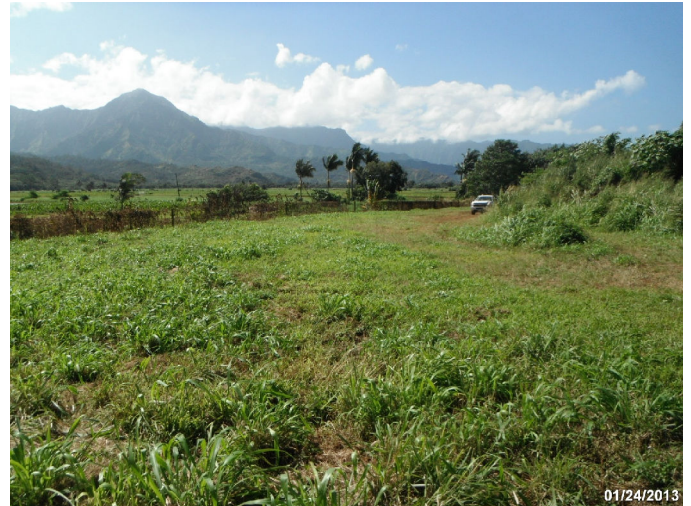
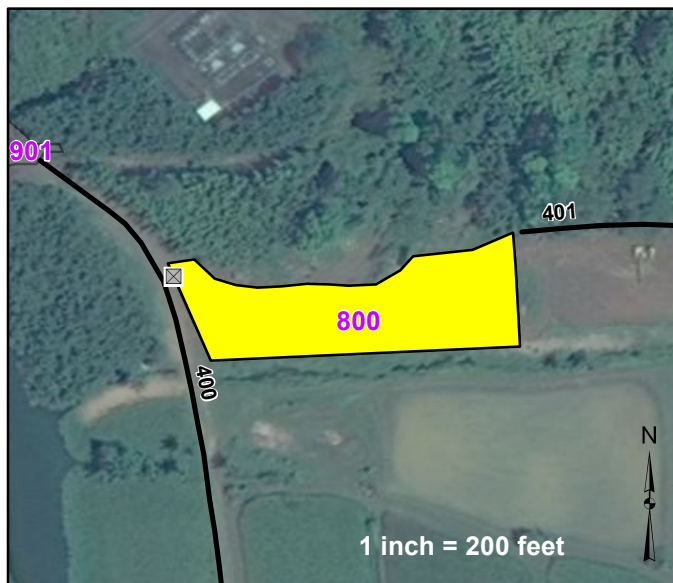
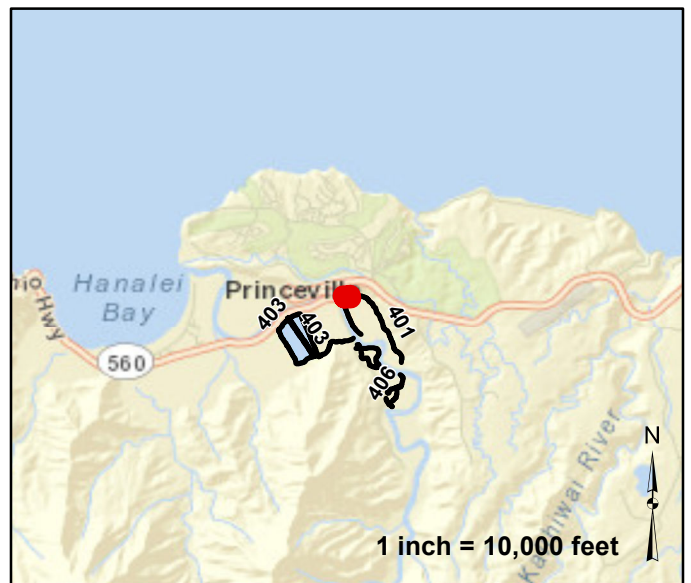
# Route Number: 800

Asset Number	Area (Sq Ft)	Spaces	Condition	Surface Type	Cost to Improve	Inspection Date	Current Replacement Value
-	27507	15	Fair	Gravel	\$10,000	01-24-2013	\$186,800

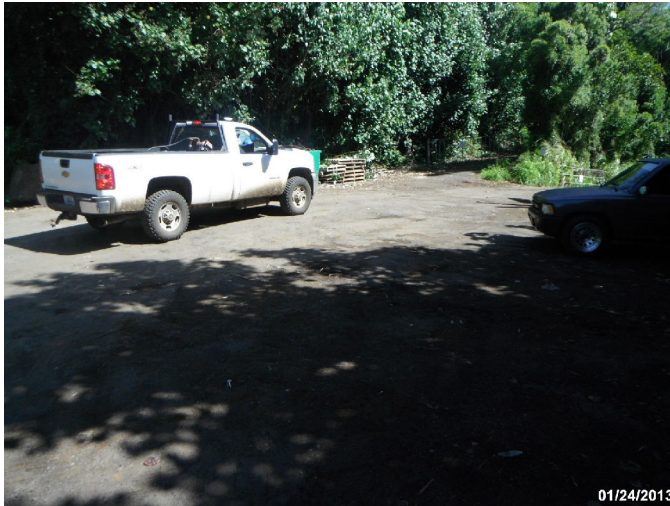
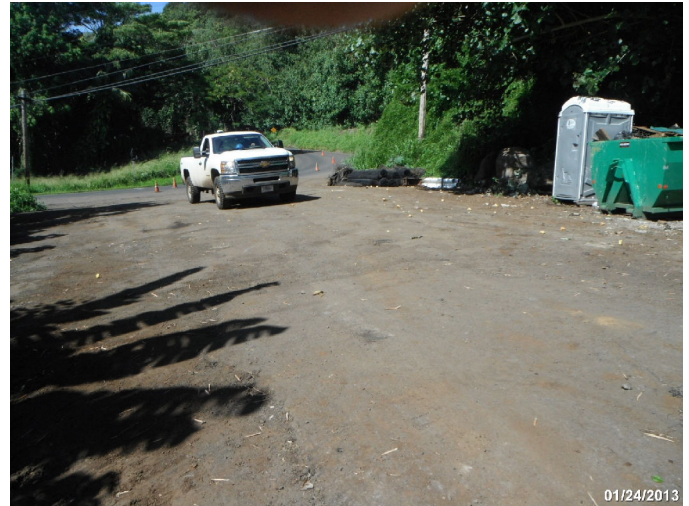
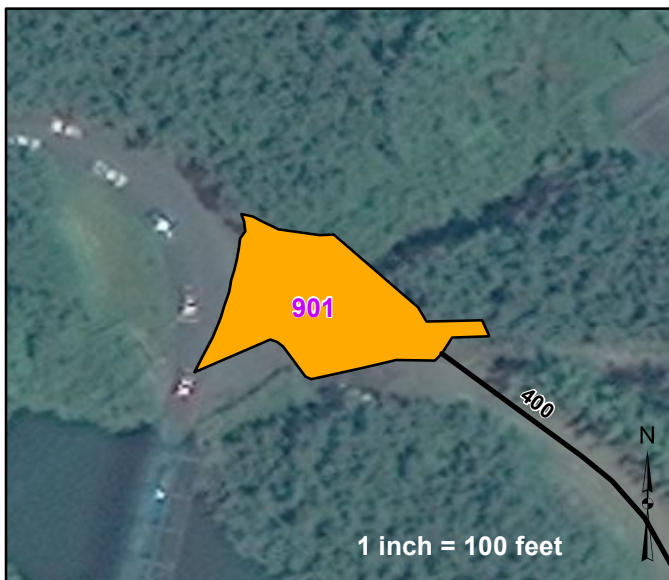
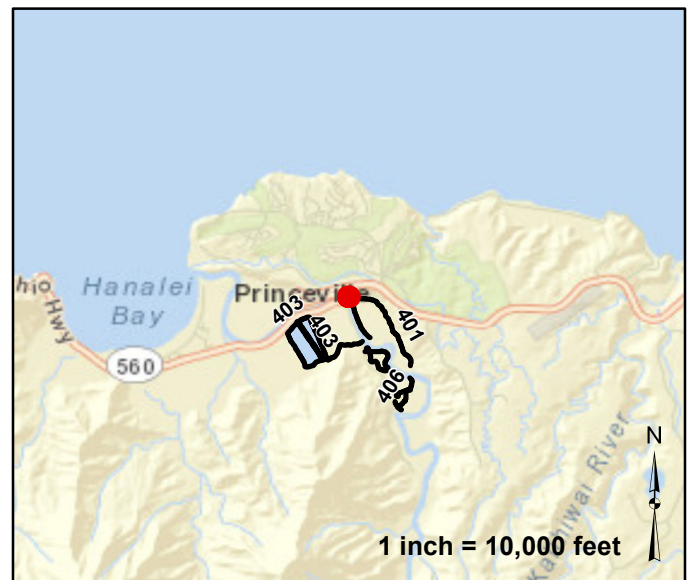
**Route Number: 901**  
**Hanalei River Bridge Pullout**  
**From Farmer Access Road (Route 400)**

Asset Number	Area (Sq Ft)	Spaces	Condition	Surface Type	Cost to Improve	Inspection Date	Current Replacement Value
-	5961	12	Poor	Asphalt	\$39,200	01-24-2013	\$74,100

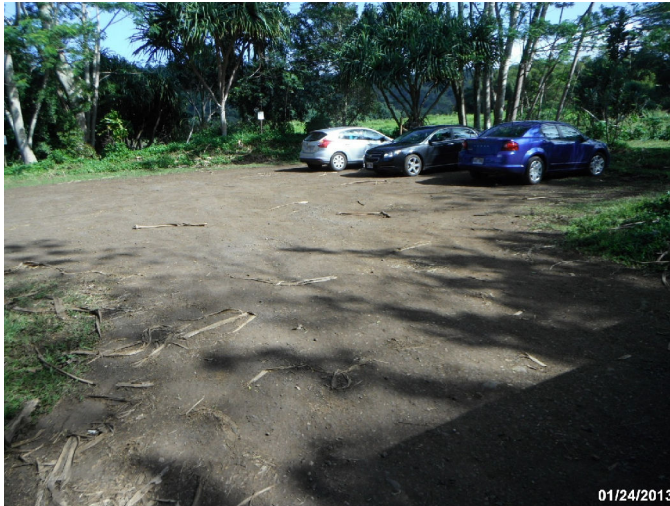
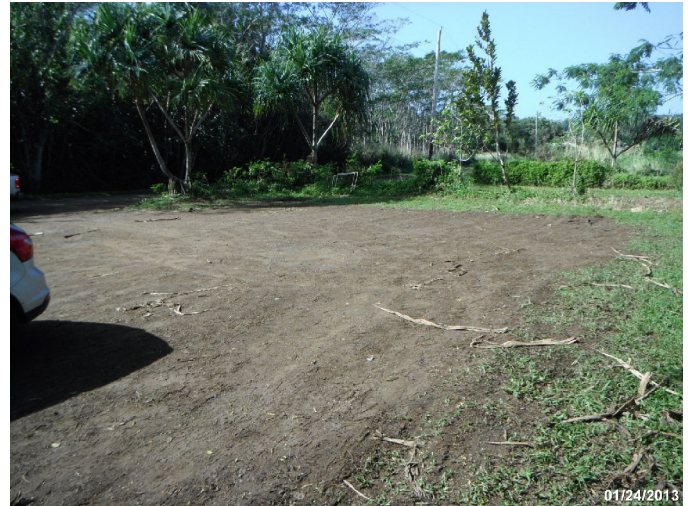
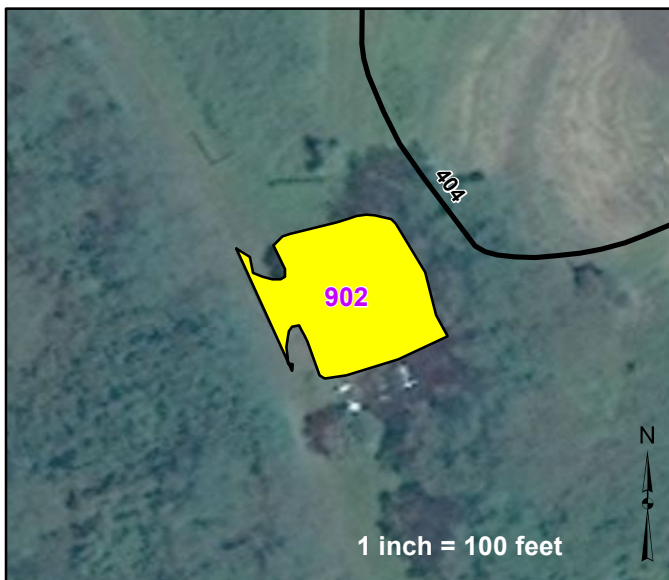
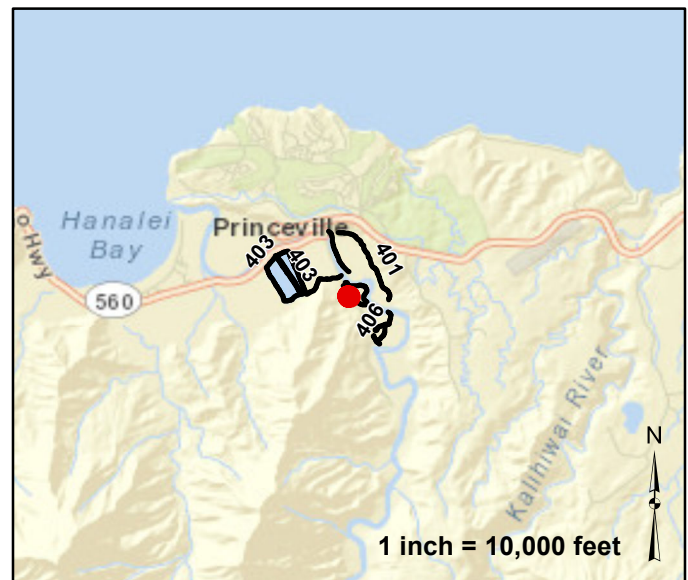
**Route Number: 902**  
**Okolehao Trailhead Parking**  
**From Ohiki Road**

Asset Number	Area (Sq Ft)	Spaces	Condition	Surface Type	Cost to Improve	Inspection Date	Current Replacement Value
-	5261	10	Fair	Gravel	\$1,900	01-24-2013	\$35,700

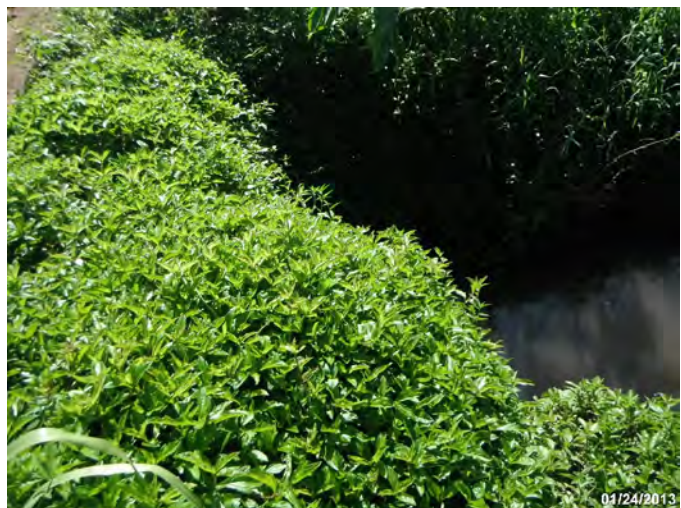
Photo: HANA\_C4\_1232 Route: 400-001-0.05  
2 Concrete Culvert 15ft long 24in dia. 4ft deep

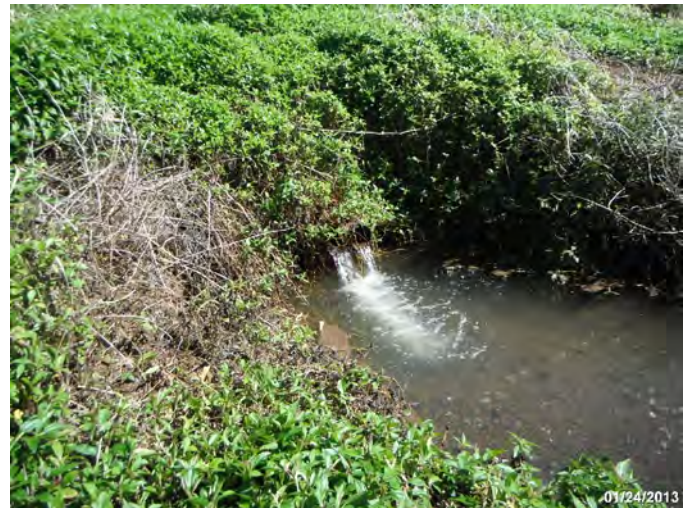
Photo: HANA\_C4\_1237 Route: 400-001-0.33  
2 Plastic Culvert 25ft long 6in dia. 2ft deep

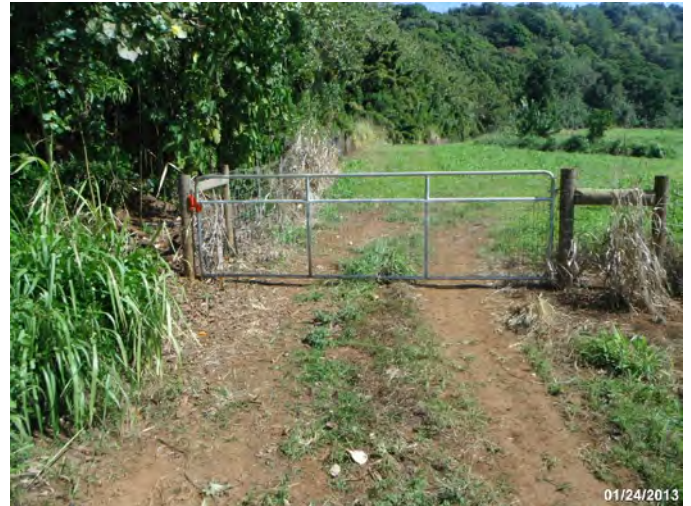
Photo: HANA\_C4\_1241 Route: 401-001-0.0  
Metal Open Rail Gate

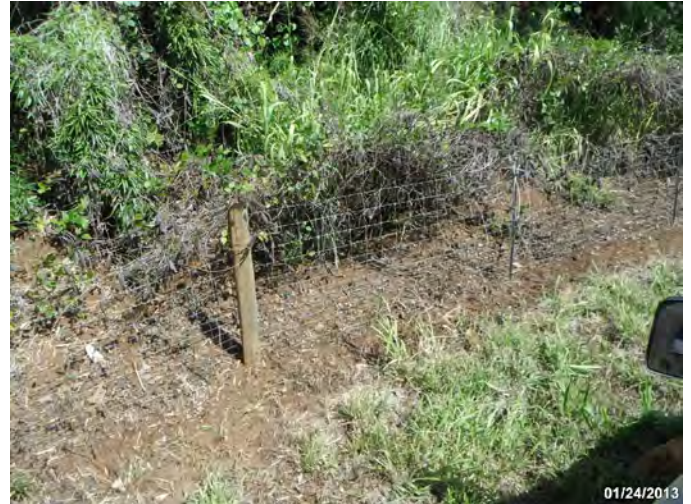
Photo: HANA\_C4\_1244 Route: 401-001-0.12  
Plastic Culvert 40ft long 24in dia. 2ft deep

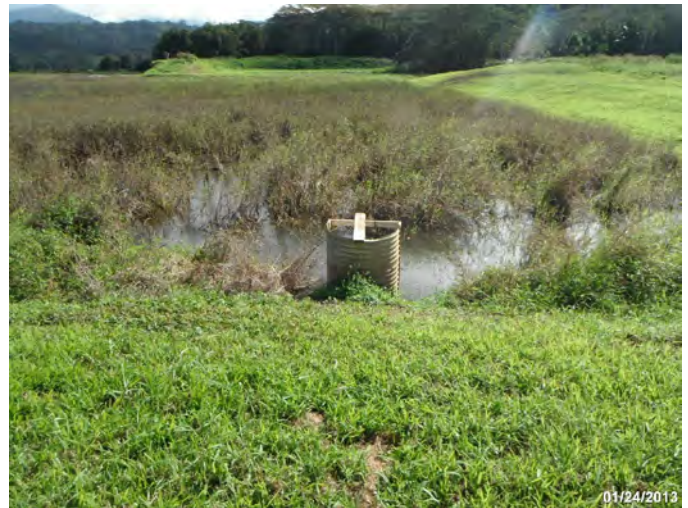
Photo: HANA\_C4\_1313 Route: 404-001-0.06  
Metal WCS Flashboard Riser 100ft long 24in dia. 3ft deep  
other end is buried in a dike

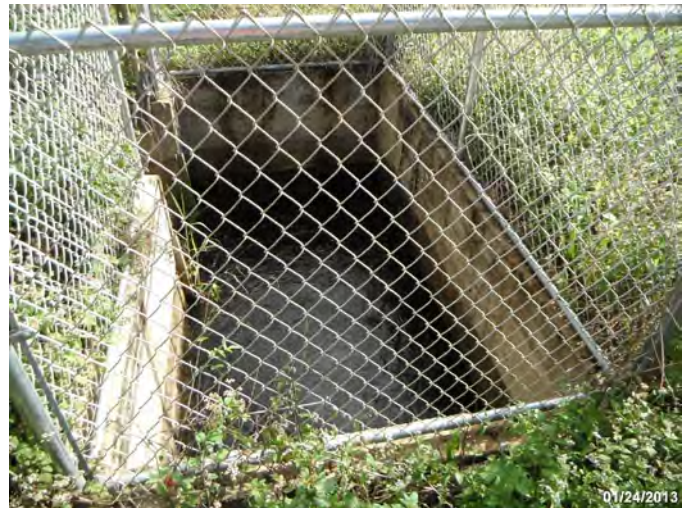
Photo: HANA\_C4\_1332 Route: 801  
Metal Culvert 40ft long 24in dia. 3ft deep
